HAZARD ALERT

WORKER KILLED IN ROCK CRUSHER EXPLOSION

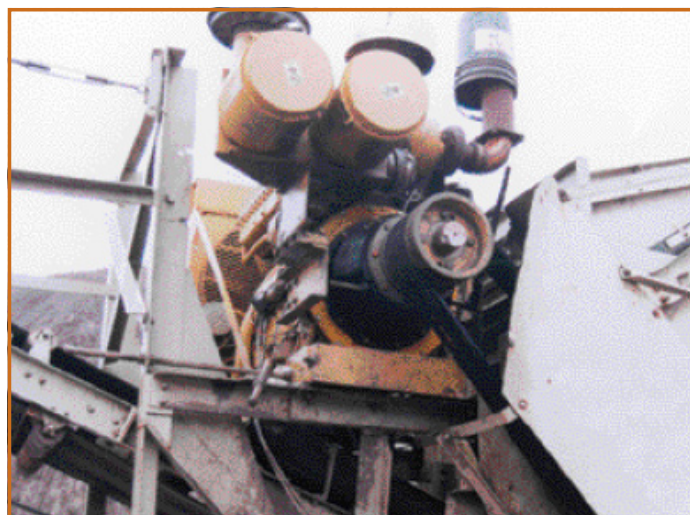
Shortly after starting up the rock crusher for a day's production, the operator spotted smoke coming from the transmission housing. The operator immediately went to disengage the clutch and look for the source of the smoke. At that instant, the transmission blew apart with the debris causing a fatal wound. One 90-kilogram (200-pound) piece flew 5.5 metres (18 feet), striking a payloader.

The WorkSafeNB investigation determined the crusher had been properly lubricated, with operational repairs made as required. However, maintenance records were not documented, nor was there a maintenance schedule.

The drive assembly typically requires 12 to 18 belts on the drive spool. For this, the supplier recommends belts for each position. Operators typically wait until it is necessary to replace an entire set of belts. To compensate for having fewer drive belts, operators must increase the tension on the remaining belts. This results in a condition known as "side loading." This condition increases the load on the clutch assembly, potentially causing the seal to leak and create excessive wear on the clutch, leading to overheating. Should the bearing lose lubrication fully, the result is an explosive disintegration of the transmission.

1. Schedule maintenance (such as all lubrication and bearing inspections), track hours of operation, and above all document all the work (lubrication by type and location, repairs made, alterations, etc.).
2. Apply the proper tension to the drive belts as per manufacturer's specifications.
3. Match the capacity of the drive unit to that of the clutch assembly.
4. Follow all supplier recommended preventive maintenance schedules.
5. Do not exceed manufacturer's recommended limits for side-pull loading.
