HAZARD ALERT

WORKER INJURED BY FALLING THROUGH HOLE IN ROOF

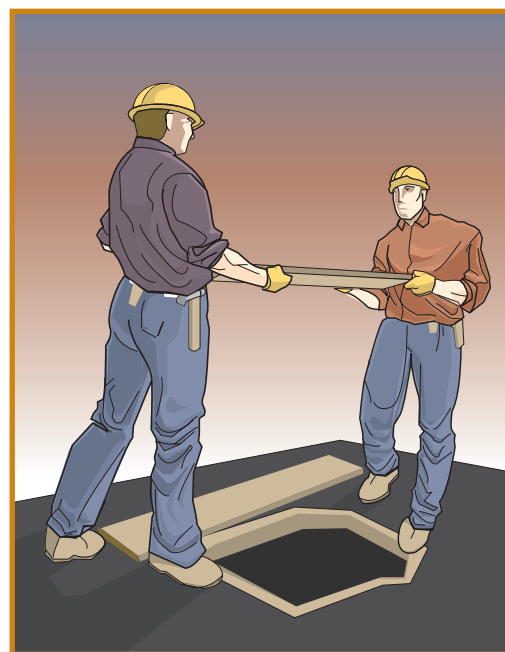
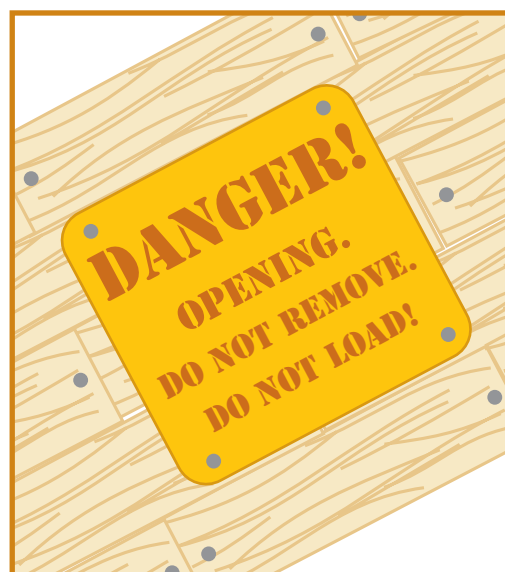
A worker suffered serious injuries while preparing for a roofing job. He and another worker picked up a large piece of plywood, one worker at each end, to remove it from the roof. The workers did not realize the plywood was being used to cover a hole that had been cut in the roof for mechanical services to the building. As they moved the plywood, one worker fell through the hole, approximately eight metres. He broke both arms and sustained injuries to his head, back and internal organs.

WorkSafeNB determined the cause of the accident was a failure to secure and identify the cover over the hole.

The workers had not been told about the hole in the roof and the plywood being used to cover it, and there was no sign or warning posted.

- Guardrails are the preferred method for protecting workers near floor and roof openings. However, guardrails may not always be practical due to narrow access. In that case, an alternate cover must be installed and marked.
- Use planks, plywood or steel plates for covers. In some cases, pallet-type designs can make covers stronger and less likely to be removed.
- Make covers stand out with bright paint. **DANGER! OPENING. DO NOT REMOVE. DO NOT LOAD!**
- Fasten the cover securely to prevent workers from removing it and falling in the hole.
- Ensure the cover is strong enough to support any load to which it may be subjected, for example, the weight of a person walking across it.
- See section 111 of *General Regulation 91-191* for detailed requirements regarding openings.
