HAZARD ALERT

TANDEM LIFT WEIGHT LIMITS CANNOT BE IGNORED

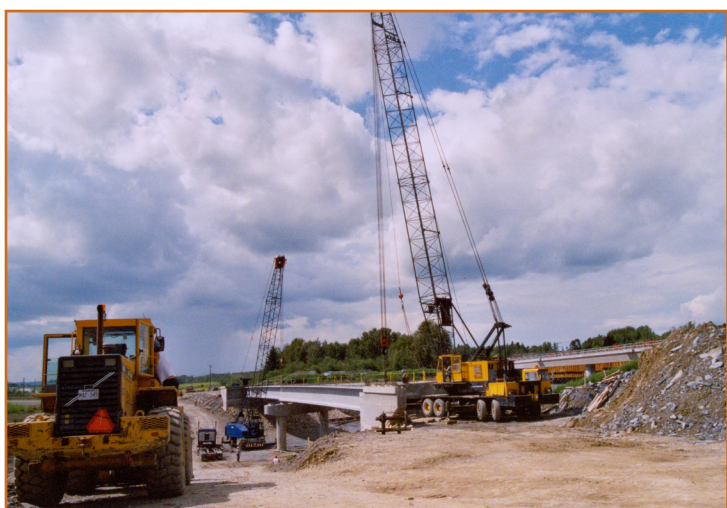
Considerable damage and expense was incurred, and two highway construction workers were injured, during a complex tandem lift involving two cranes. A 90-foot lattice boom collapsed when the work radius and weight capacity of a crane to lift a 40-foot concrete beam was miscalculated. The cause of the incident was a failure to stay within the crane's safe operating limits.

One side of the beam had already been raised when the second crane's operator was instructed to raise his end of the concrete beam. Movement of the load caused the back end of the first crane carrier to rise about 3.6 m in the air. The beam was quickly lowered to the ground causing the lattice boom to strike the capbeam. This resulted in the crane carrier dropping back on its wheels, thereby creating a spring action in the boom. The boom fell backwards, hit the crane cab and collapsed onto a nearby truck. Five workers in the immediate vicinity could have suffered severe injuries or death.

An investigation concluded that proper planning and procedure was not in place at the time of the incident.

1. Lifts involving two or more cranes are complex operations requiring considerable skill and planning. As a result, multiple crane lifts (or critical lifts) must be planned and carried out under a competent person's supervision.

2. The employer and a contractor must develop and communicate a detailed critical lift plan that contains, but is not limited to, the following:
 - Rigging details

- Wind speed limitations
 - Maximum hoist line speed
 - Maximum crane travel speed, if applicable
 - Details concerning load distribution
 - The need for position of the signalers

- A description of an effective communications system that the employees involved must follow
3. The employees involved in the lift need to be made aware of the critical lift plan prior to the lift and at any time that there is a change in persons involved. A copy of the plan needs to be available to all involved.

4. The employee shall comply with the plan and the employer shall ensure all employees comply.
5. Boom angle indicators are required on all mobile cranes, but they must not be relied upon for accuracy in critical lifts such as tandem lifts. A load moment indicator (LMI) gives an accurate angle as well as loading throughout the lift.
